# Eclipse Datalog Drill Report

Project: Kairi tee kuni MK17 De50  
Address: Valma

Contractor: Gabariit OÜ  
Address: Tedre 30  
Tallinn

Date: 14.09.2011  
Time:

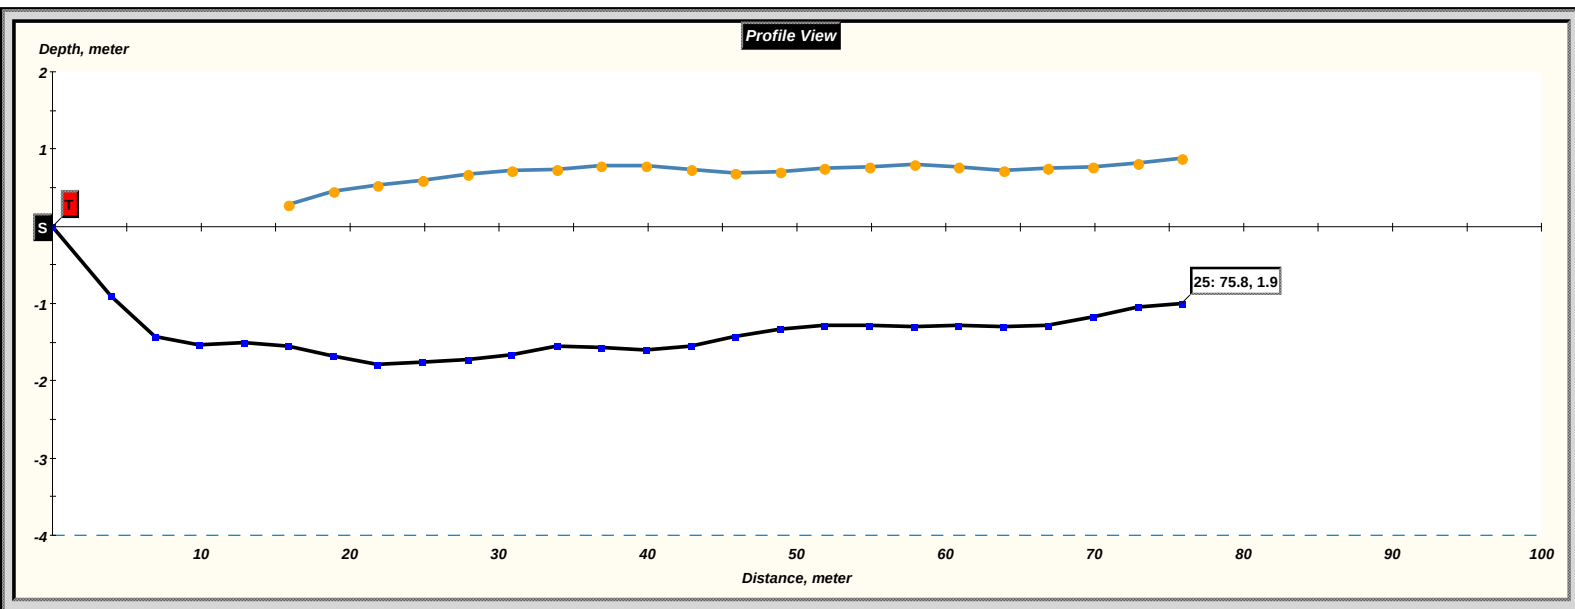
| Rod | xDist<br>(m) | Pitch<br>(%) | Depth<br>(m) | iDepth<br>(m) | Rel. Elev.<br>(m) | Type |

*This report contains a log of data taken by above-ground locating equipment during below-ground drilling. Because the accuracy of such data can be adversely affected by environmental and operational factors, the data does not necessarily provide an accurate representation of actual site conditions.*
